# Theory Exercises

**Gearbox and Bearing  
Maintenance**

**Gearbox inspection**

## Case Nordex 800

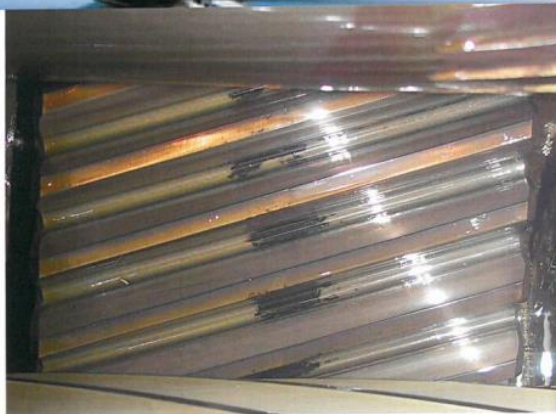
LSIMS Wheel  
Normal running in wear

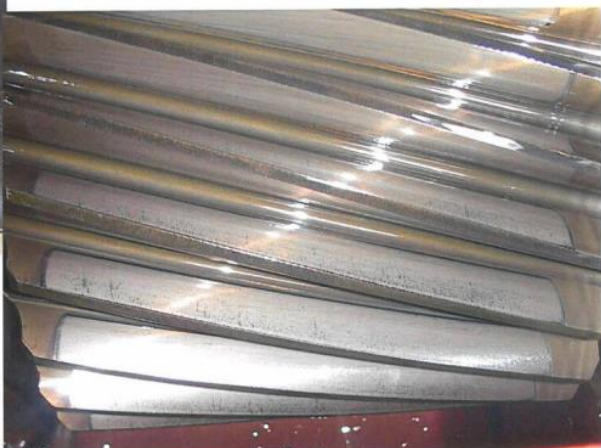
HSIMS pinion  
Indentation marks and  
scuffing  
from particles

- Wear occurs in the gearbox on the wheel on IMS and the HSS pinion.
- Claim to the manufacturer.
- Inspect the gearbox before end of warranty.

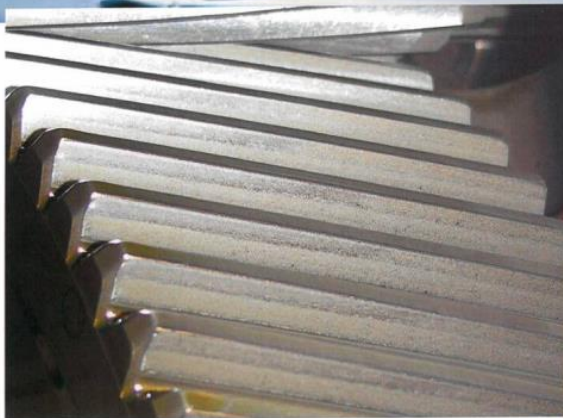
HS IMS Wheel  
Micro pitting  
Two coloured appearance

- The wheel is loose on IMS.
- The wheel has probably been loose since installation. This is the cause of the two-coloured appearance micro pitting and the high iron content.
- The collar on the NJ-bearing on IMS has broken off.
- When the wheel is loose the axial forces on the teeth will force the wheel towards the rotor-end bearing giving extra load on the collar.

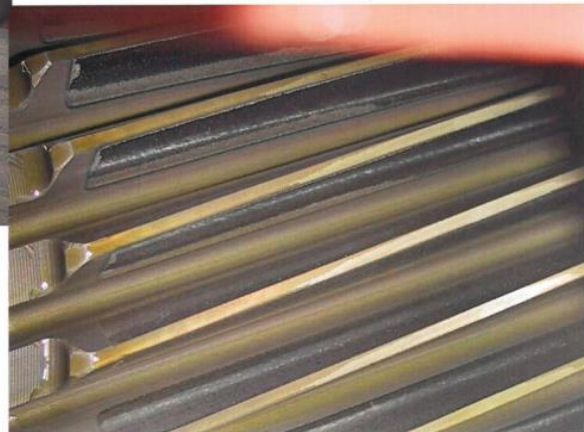
HS pinion  
Micro pitting on the inner half.

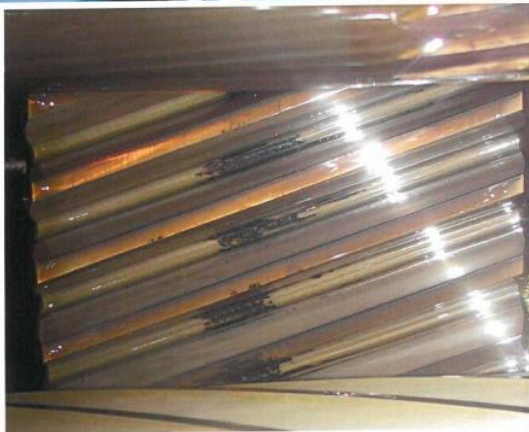
LS IMS Wheel  
Normal running in  
wear

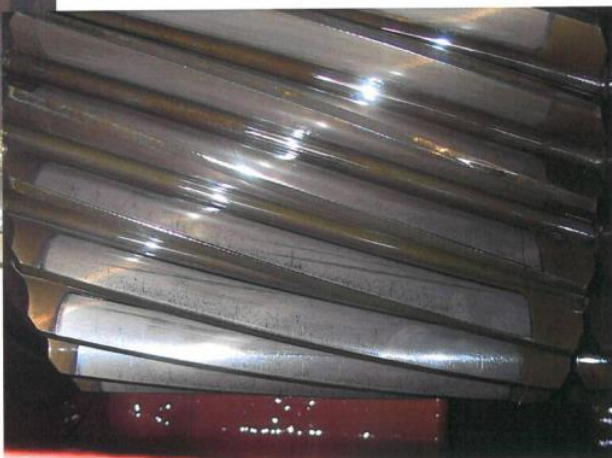
HS IMS pinion  
Stand still marks  
Indentation marks and  
scuffing  
from particles

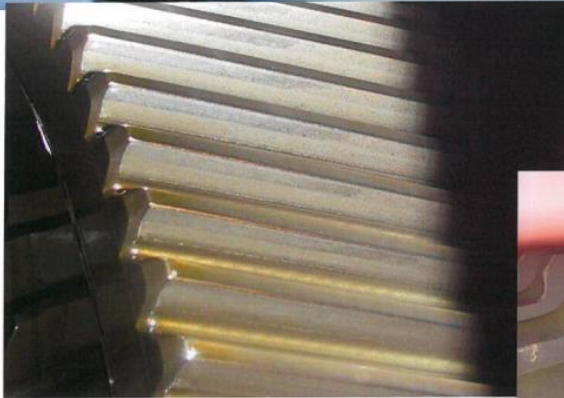
HS IMS Wheel  
Micro pitting  
Two coloured appearance

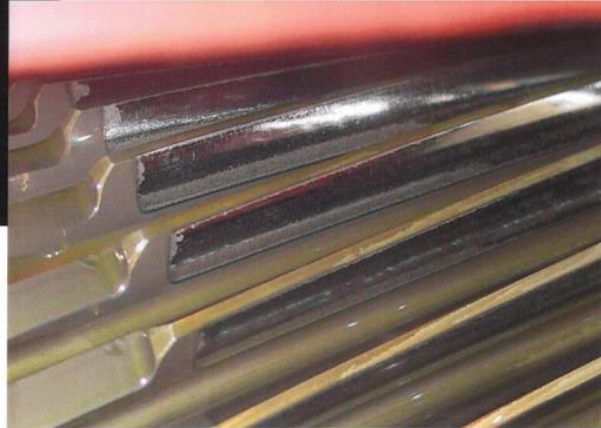
HS pinion  
Micro pitting on the inner  
half.

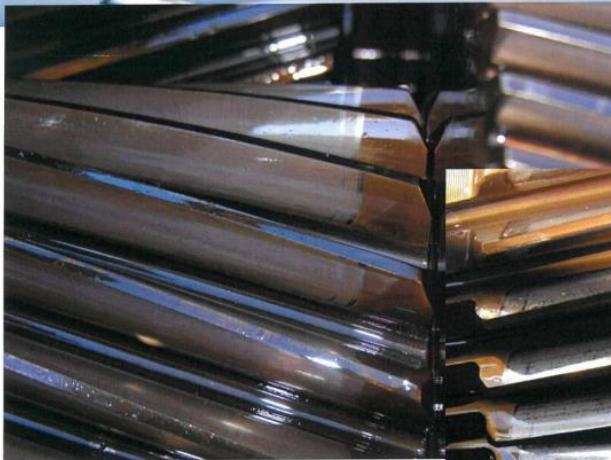
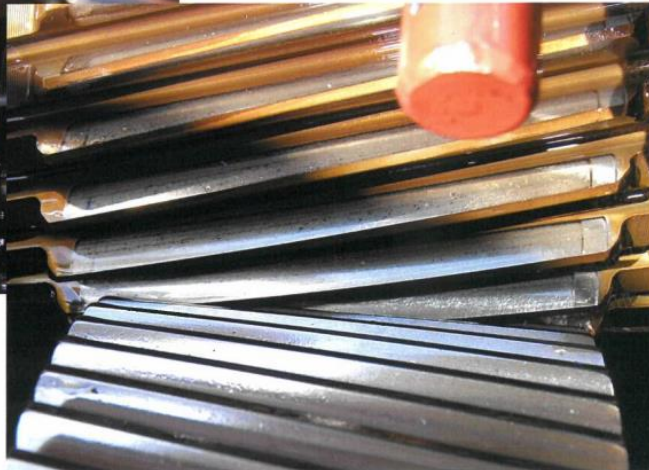
HS IMS pinion  
Marks from two running  
positions

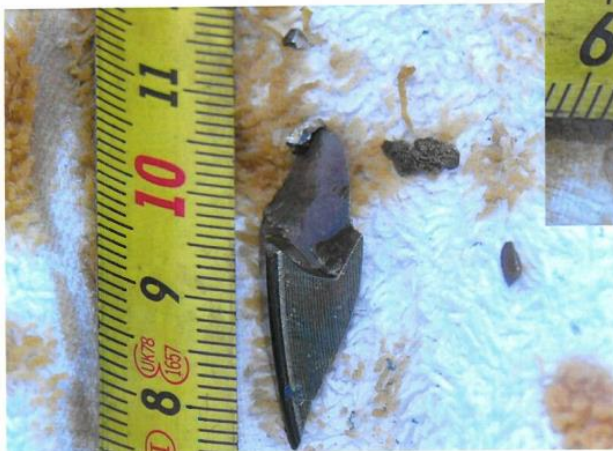
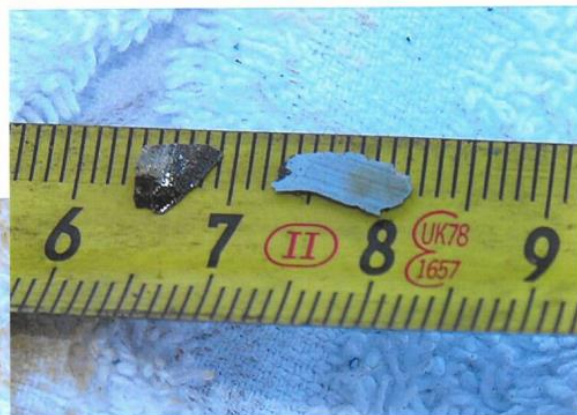
Particles found in the bottom  
of the gearbox with a magnet.

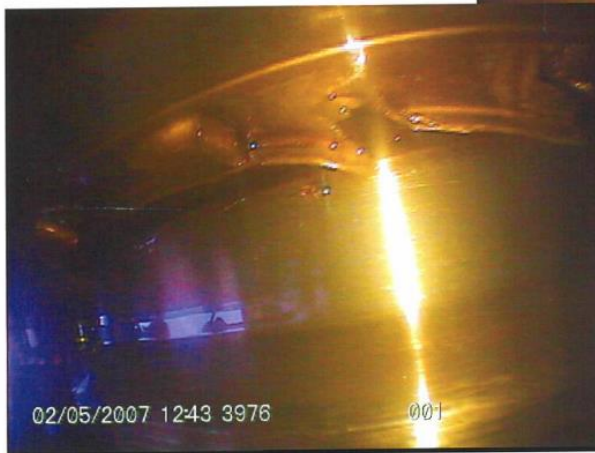
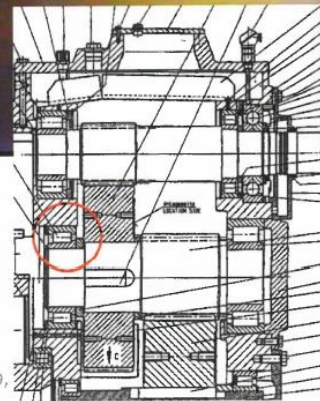
Roller cage with heavy damage.  
Collar on NJ-bearing broken off.

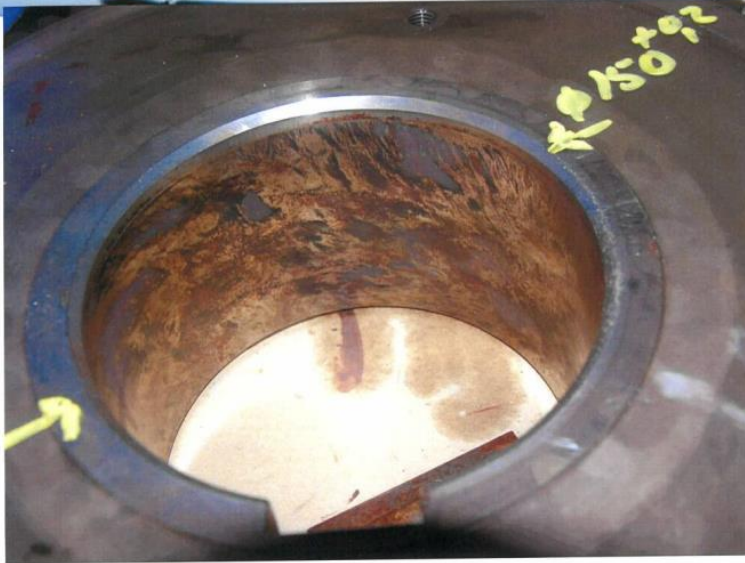
HS IMS wheel.

Fretting corrosion on the bore surface +0,2 mm

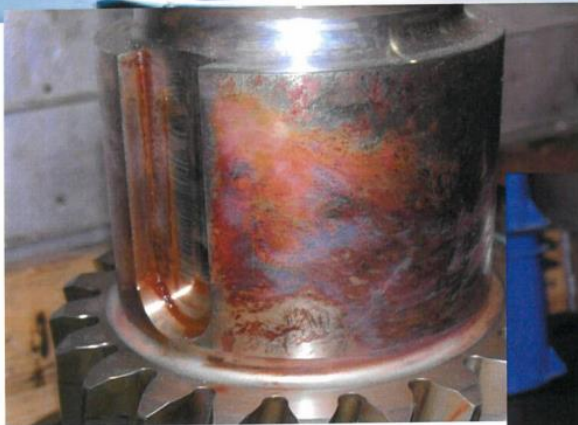
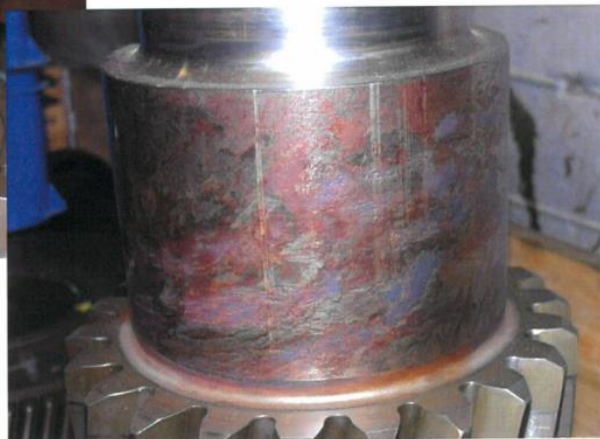
HS IMS.

Fretting corrosion on the  
surface

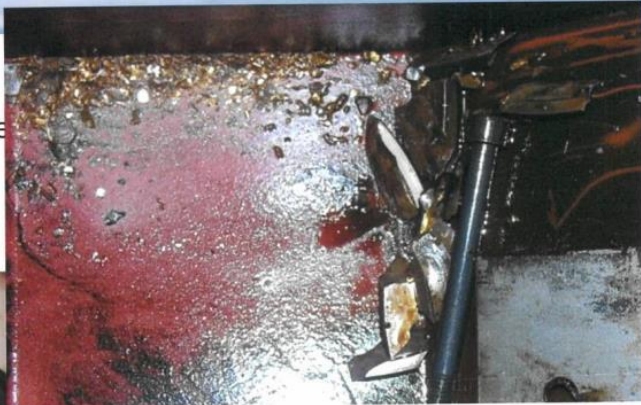
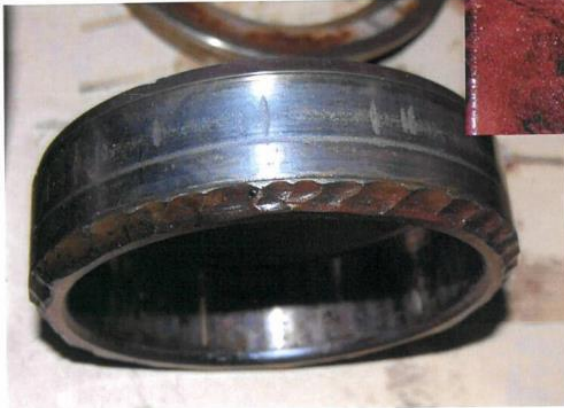
IMS. Rotor-end bearing  
The collar is broken off on the  
entire circumference

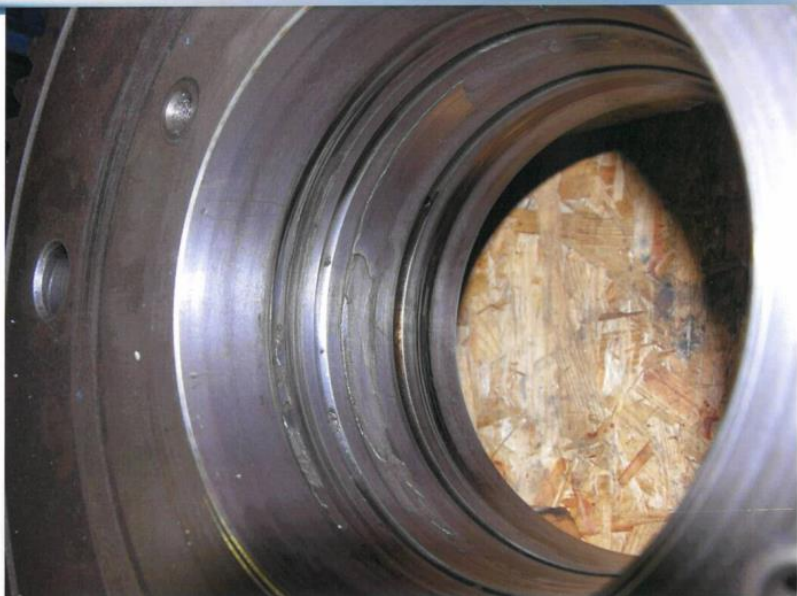
HS IMS wheel  
Scuffing in bore.

The wheel is  
pressed on the  
shaft, and no key  
is used.

- The wheel has been loose on the shaft
- The bearings on the LSIMS are not damaged
- The bolt are worn 10 mm, so the wheel have moved on the shaft several times
- The damage on the 2 teeth is started with pitting and the material has cracked off due to this pitting
- The damaged is not covered by insurance

- The wheel has moved on the shaft only once. After that the damage in the bore show that the 2 parts are grated together
- The missing material has scaled off first, and then the pitting is formed. One extreme load has deformed the teeth and started cracks
- The extreme load has deformed the casing, which explains the 10 mm wear on the bolt heads
- The marks on the HSS proofs only one move of the wheel
- The insurance company covered the damage

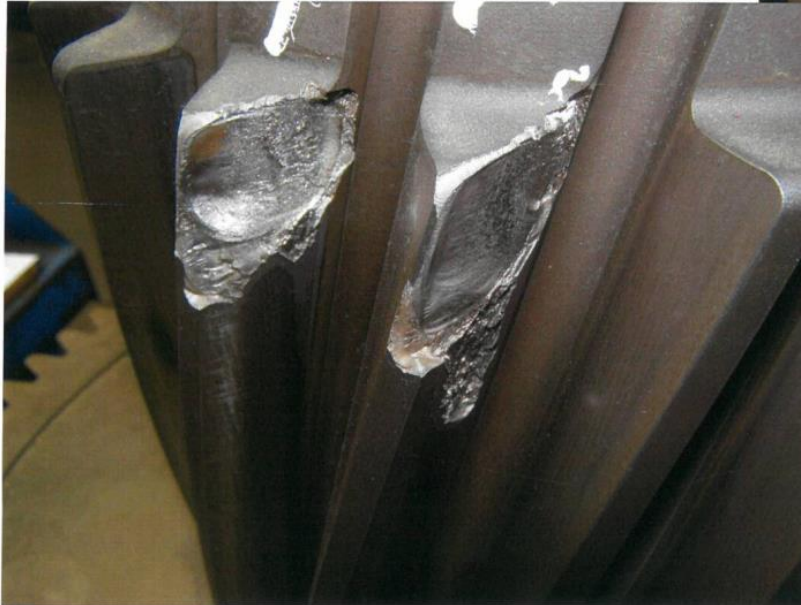
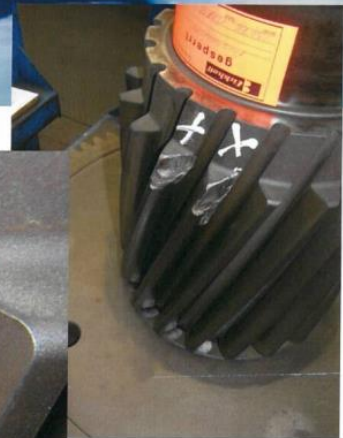
HS IMS Pinion.

Damage on 2  
teeth.

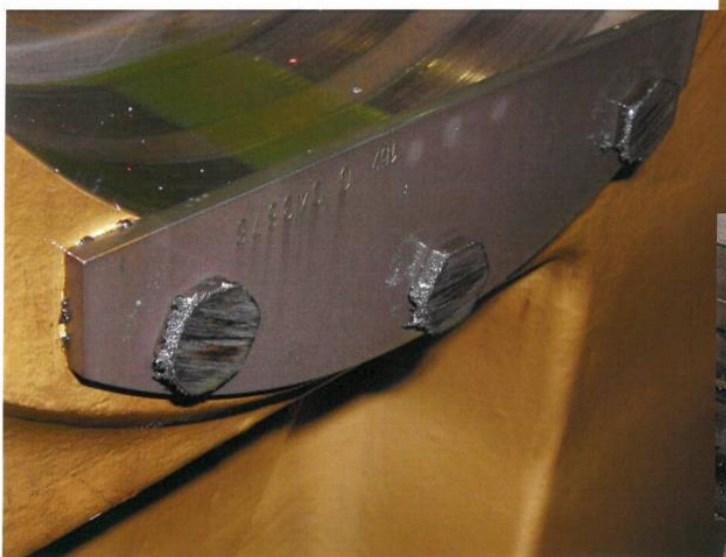
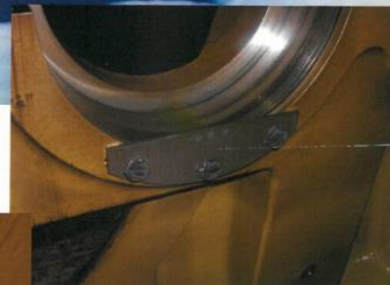
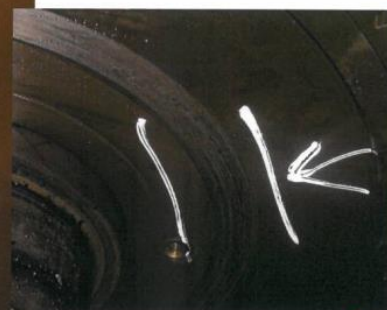
HS IMS wheel has worn  
3 bolt heads ~10 mm.
